**CALIFORNIA UNDERGROUND SAFETY BOARD
INVESTIGATION DIVISION**

INVESTIGATION REPORT

Case No.: N2426076

Investigation:**Notification of the Incident**

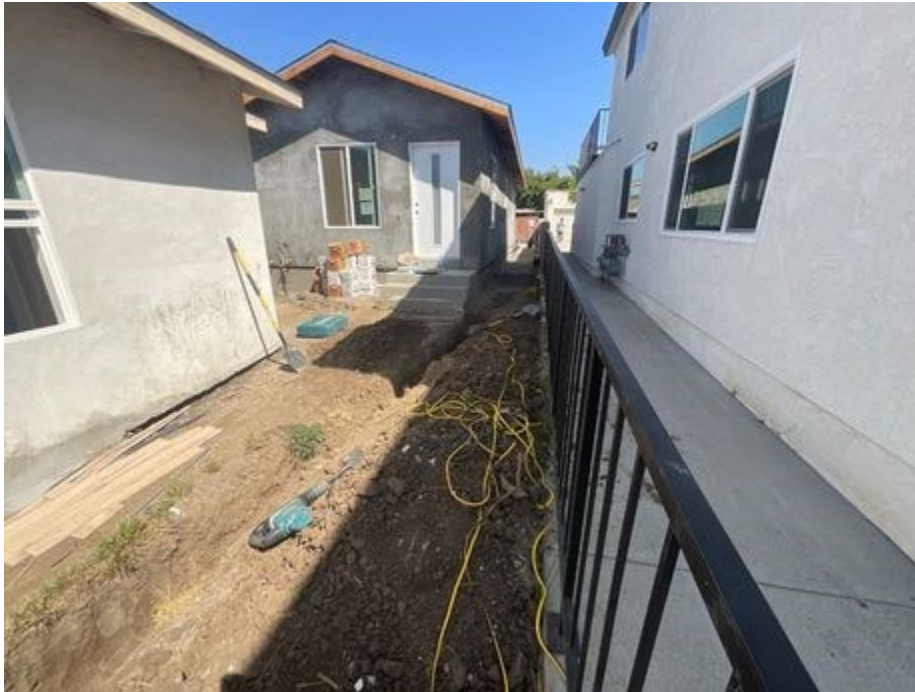
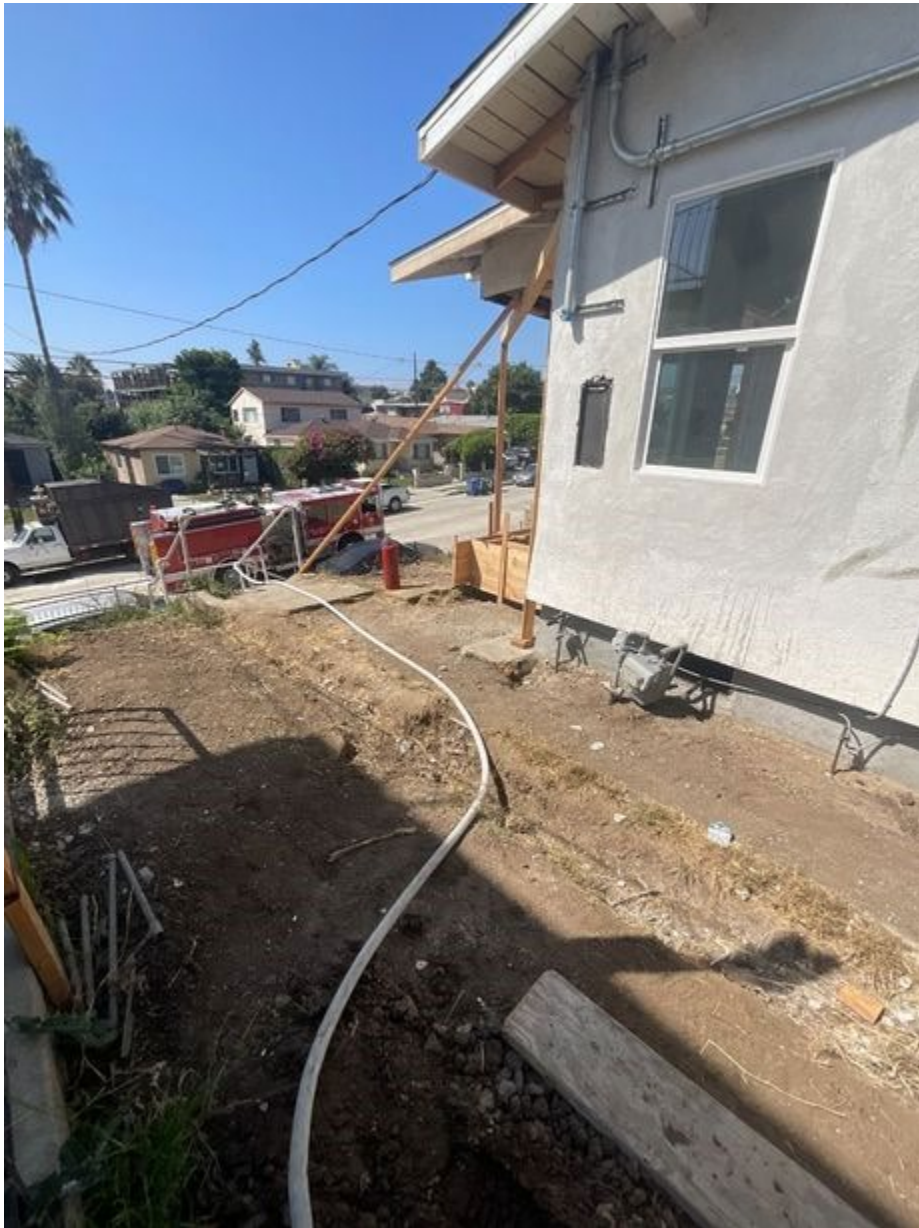
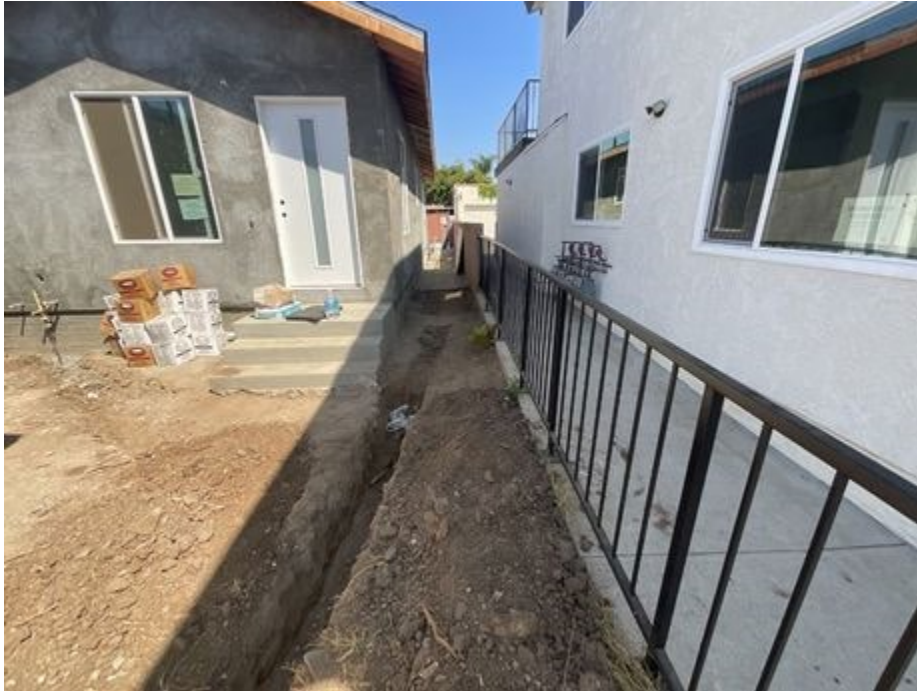
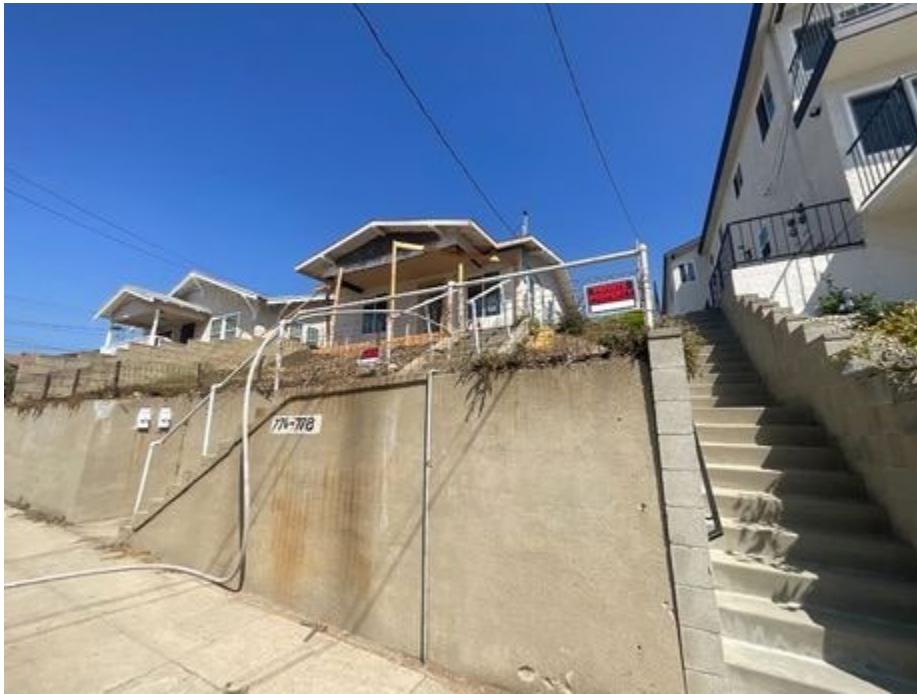
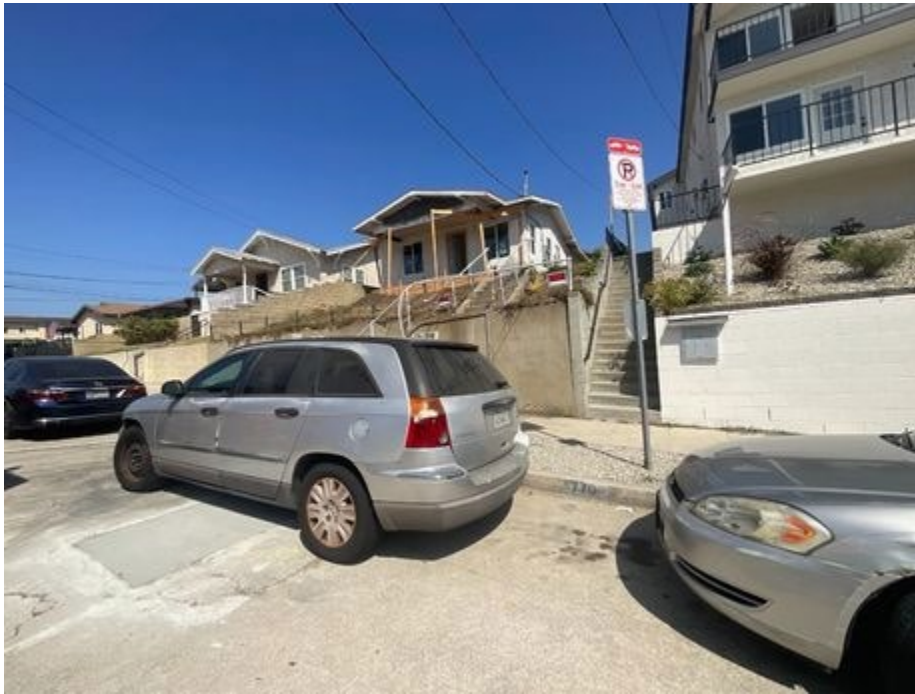
Please attach all Photos.

3rd party contractor hand excavating for electric conduit install struck and damaged

3/4" gas service was damaged and resulted in gas escape.
