**Subject:** Liberty's Response to Notice of Violation – NOV\_CAD\_LU\_IAG\_20250506\_1140

**Finding:** Failure to remove tree attachment.

| Notice | Violation # | Structures |
|---|---|---|
| NOV_CAD_LU_IAG_20250506_1140 | Violation 1 | 61336 |

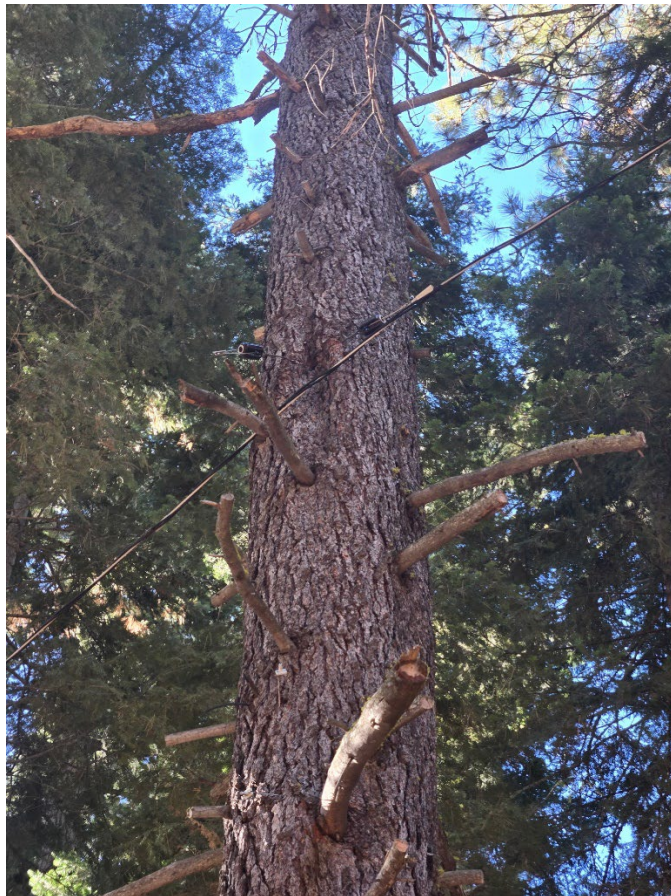
#### Photo 1

Liberty disagrees with Energy Safety's observation that it failed to complete the removal of a tree attachment at the pole ID 61336 location as reported in its Quarter 4 2024 WMP quarterly data report. Liberty's Fulcrum application indicates that a tree attachment was removed by troubleman Del Bullard on October 29, 2024. Fulcrum also indicates that there is a second, in service, tree attachment at that pole location.

In addition to the Fulcrum recording of this tree removal, the photos below show the tree attachment no longer in use. That tree attachment was used to support a span to a nightguard that was also removed. The photos show that secondary work did occur at the pole ID 61336 location, supporting the recording made by Liberty's troubleman in Fulcrum.

Liberty's GIS system does not include all secondary tree attachments, and Liberty's fixed-wing LiDAR does not capture all secondary tree attachments as they are often below and/or behind the tree canopy, so that data does not help to supplement the documentation of the removal of this tree attachment. Beginning in Q3, 2025, Liberty now reports additional tree attachments, if applicable, where tree removals occurred as part of its GIS submissions to help both the Company and Energy Safety identify when multiple tree attachments exist.
