IID 2021 IID Service Territory Field Survey

Introduction and Summary

Rough field notes and pictures – numbers represent pole numbers when they were visible

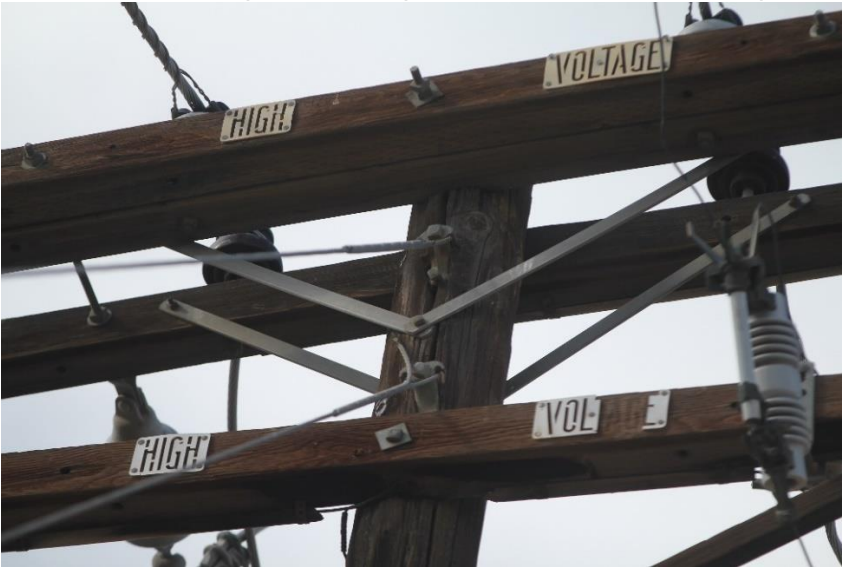
- 2276d - need split bolt at top; lot of strain on dead end pole, 6 guys, some bowing, inspect soon

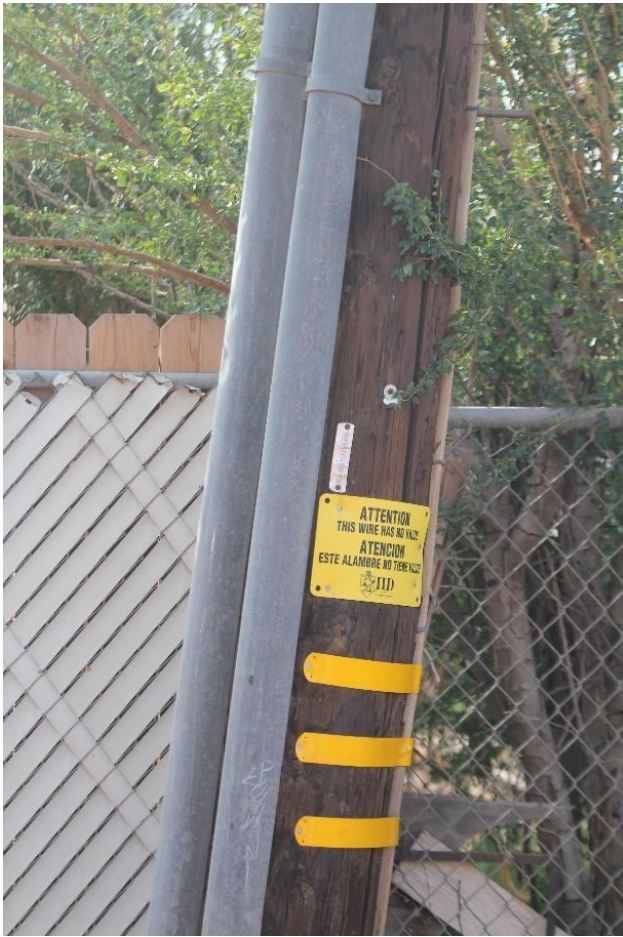
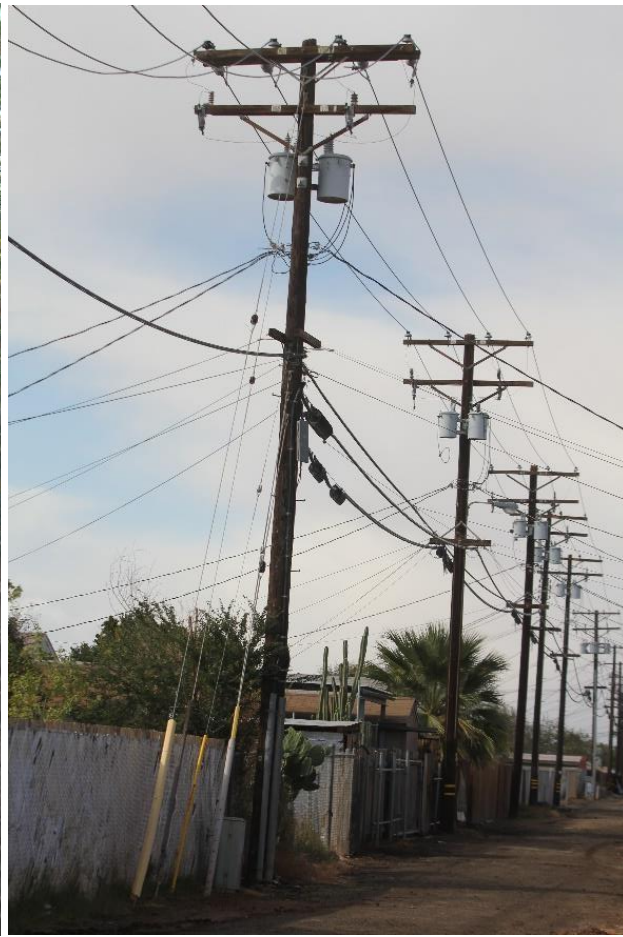
- 1219098 - need split bolt

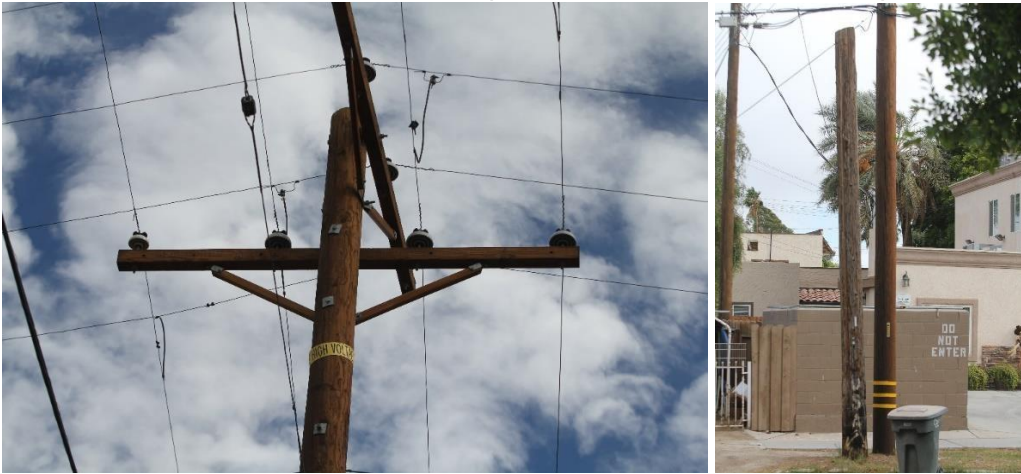
- 1240003 Add load break cutouts: phone co. should take out old pole

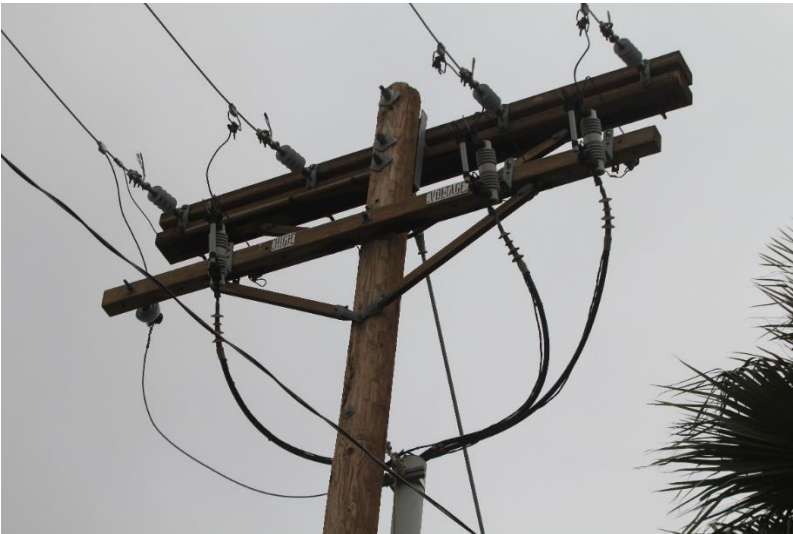
- 1167208 add load break cutouts

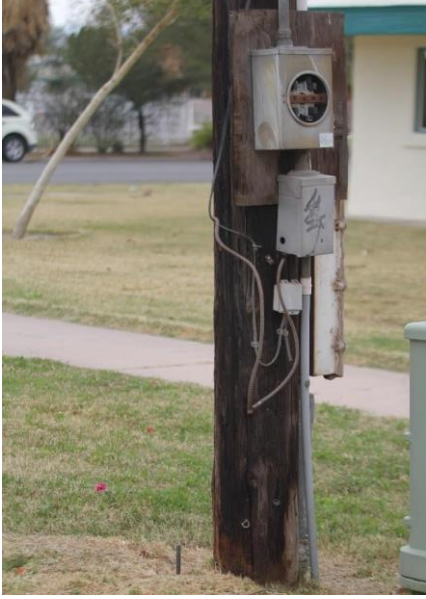
- 41300d old pole, exposed meter base, next to new pole of same number (pole not owned by IID)

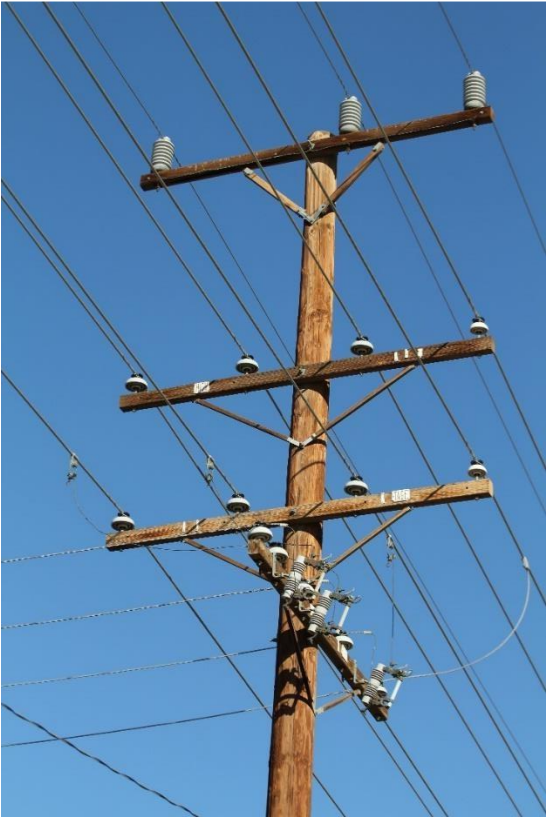
- T1540d add loadbreak cutouts, also tracking on top arm; need high voltage signs; need to ensure that common neutrals are meeting GO 95 regulations for grounding on main lines and tap lines along with ohm readings to comply. GO 95 requires CN signage on the arms where the common neutral is positioned.

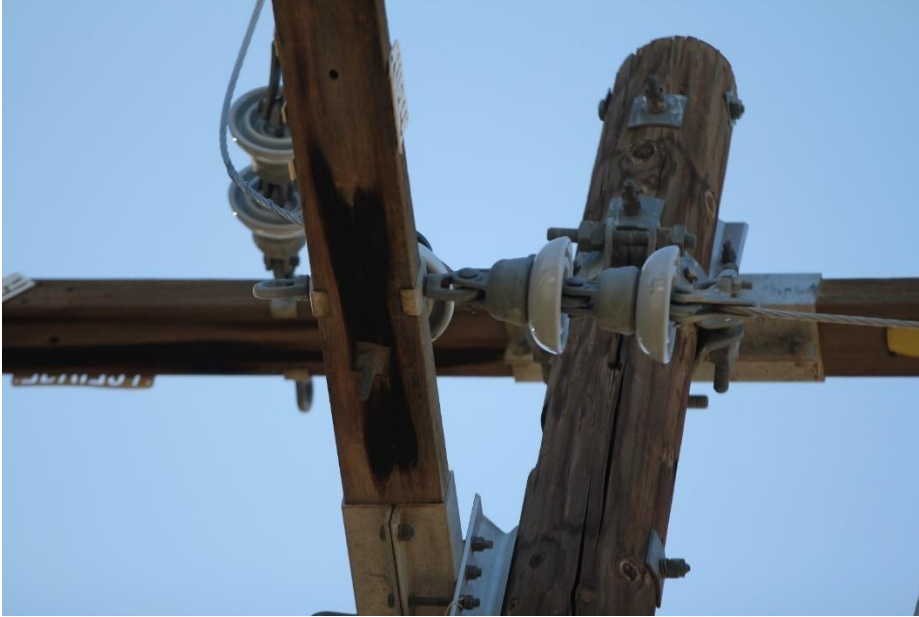
- 60963 tracking

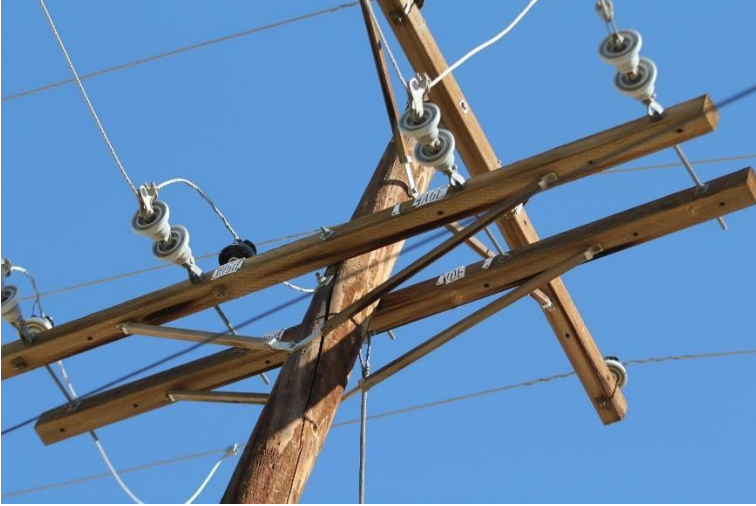
- B724 tracking, voltage signs

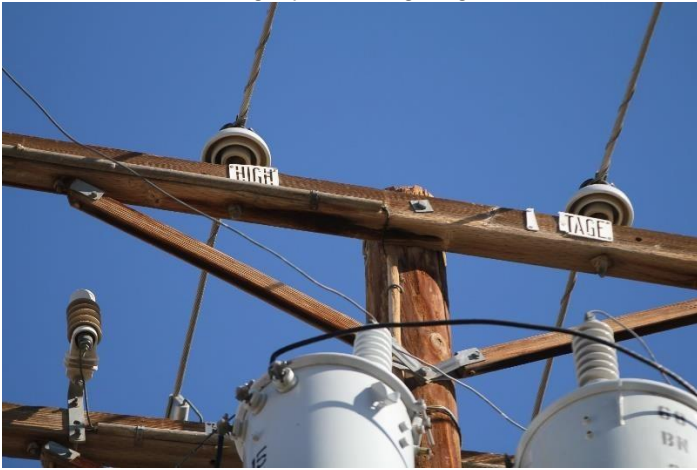
- 11333d tracking by molding, signs

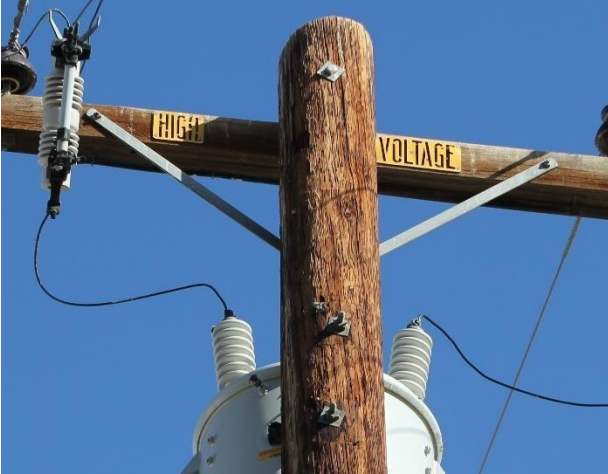
- 906878d no bolt covers

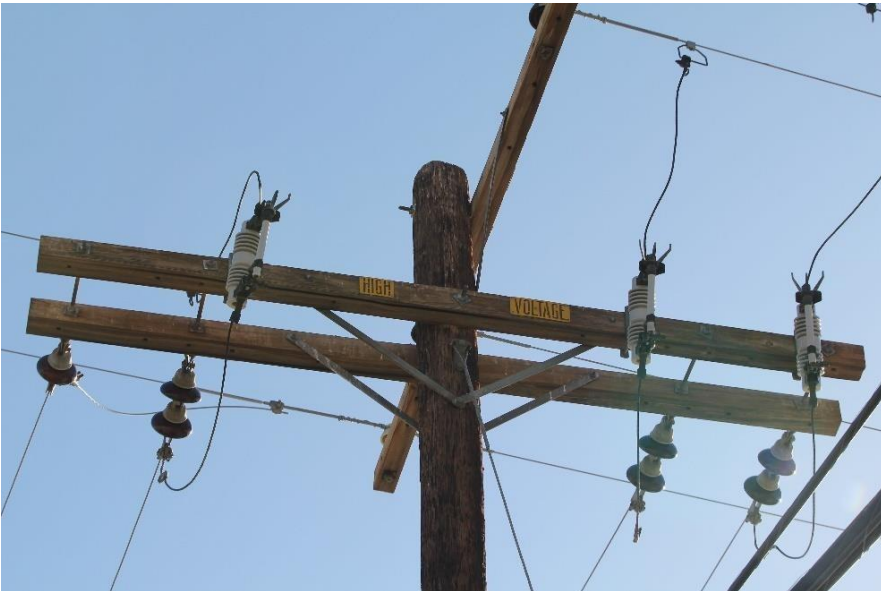
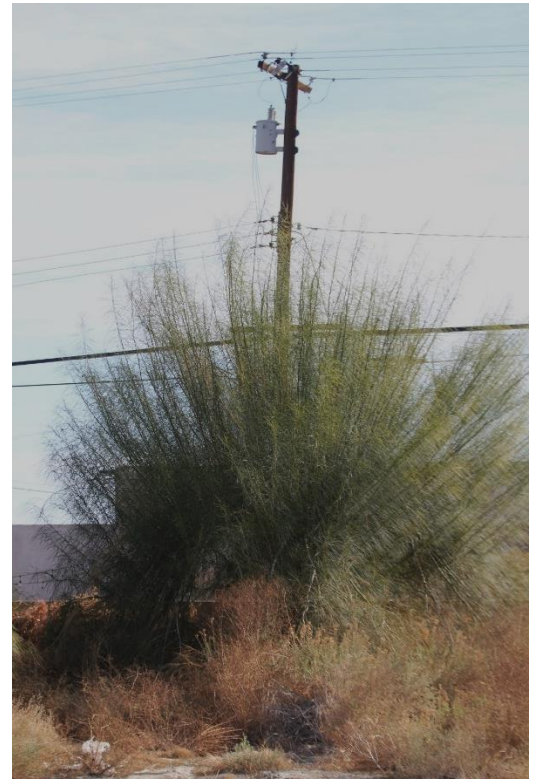
- 98391d no pole steps; second pic is of pole to north - can't access pole number due to vacant lot vegetation at base

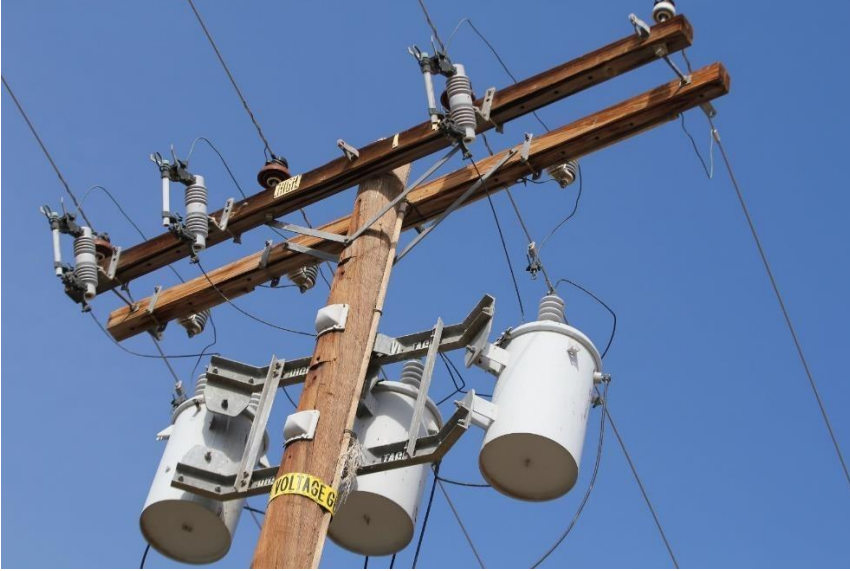
- 9895 no pole steps, arrester ground, tracking with common neutral

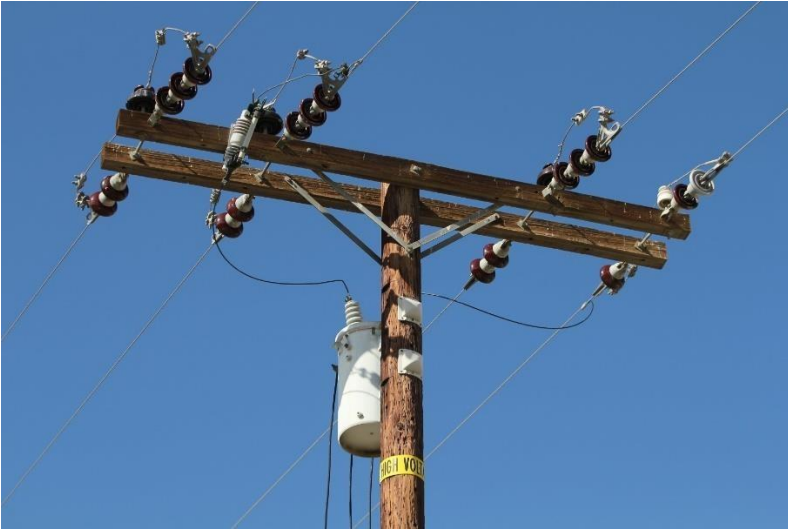
- 901557d system neutral is not grounded at the transformer pole; neutral, no pole steps

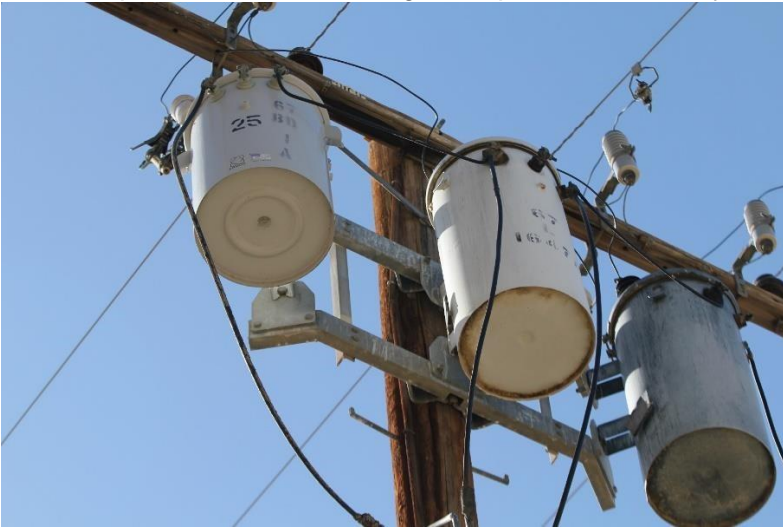
- 916232 private ranch - tracking; next pole 10 feet away

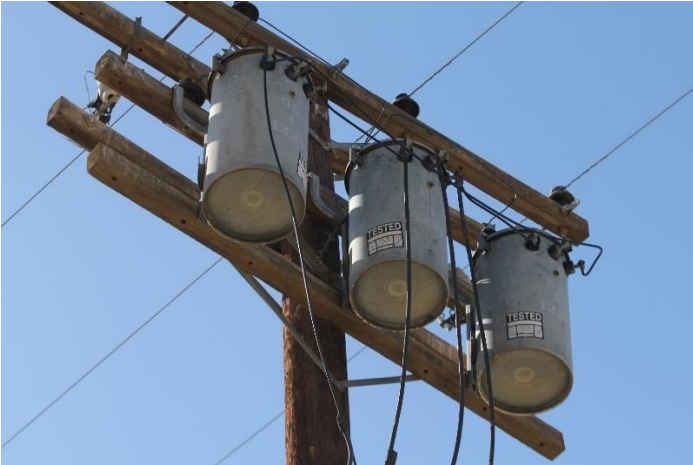
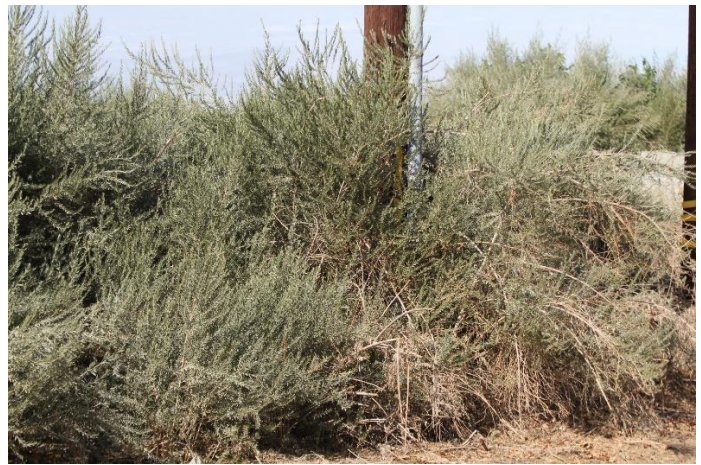
- 901796 No ground on primary arm, no tracking, bird contamination, no signs, no steps, need to clear veg

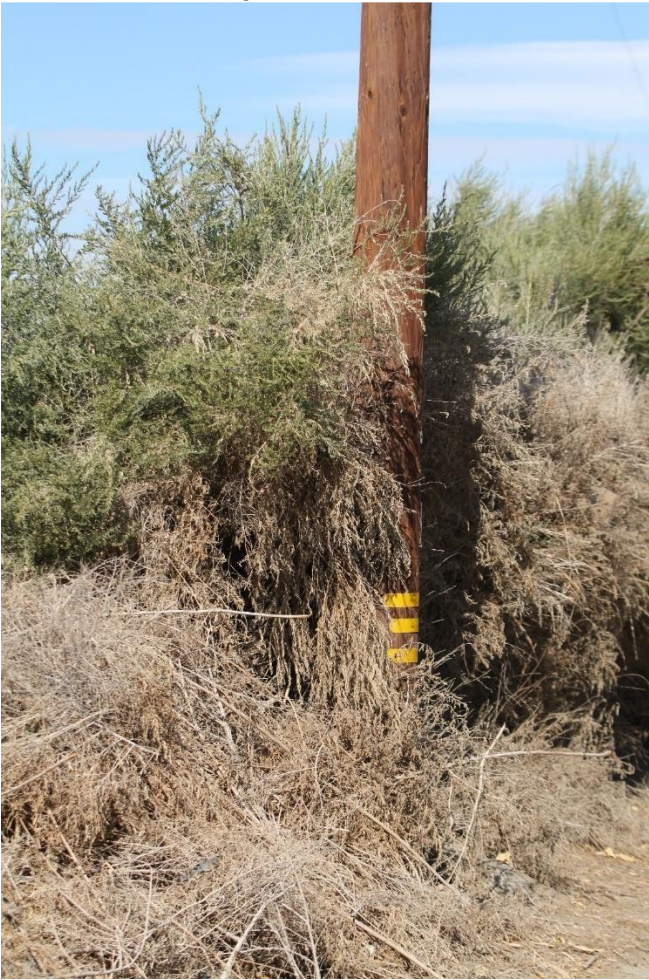
- 901795d clear veg

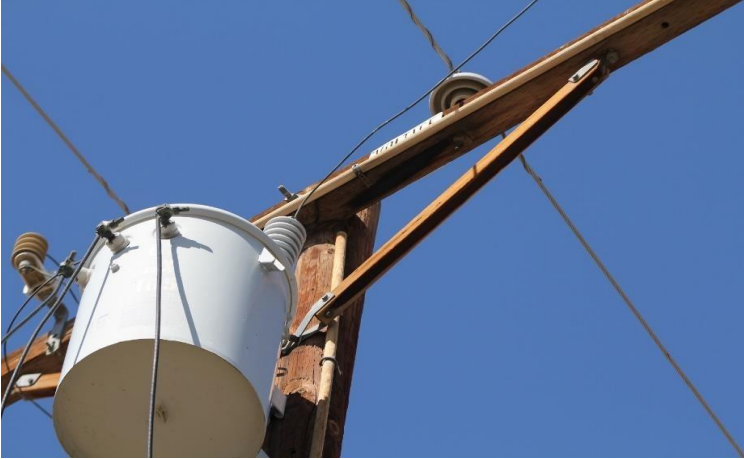
- 97947d tracking, no steps

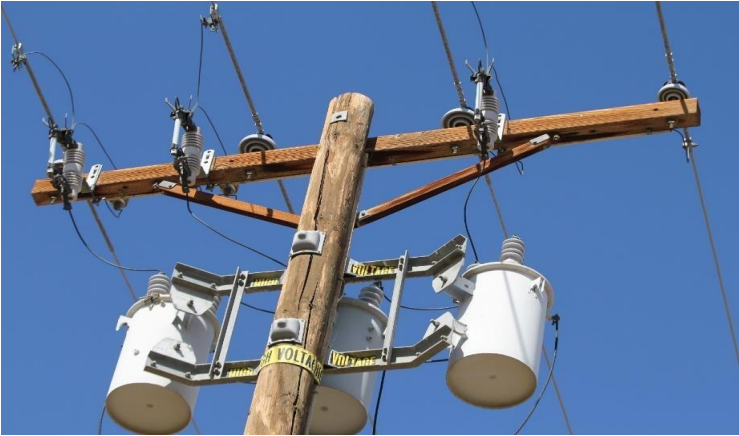
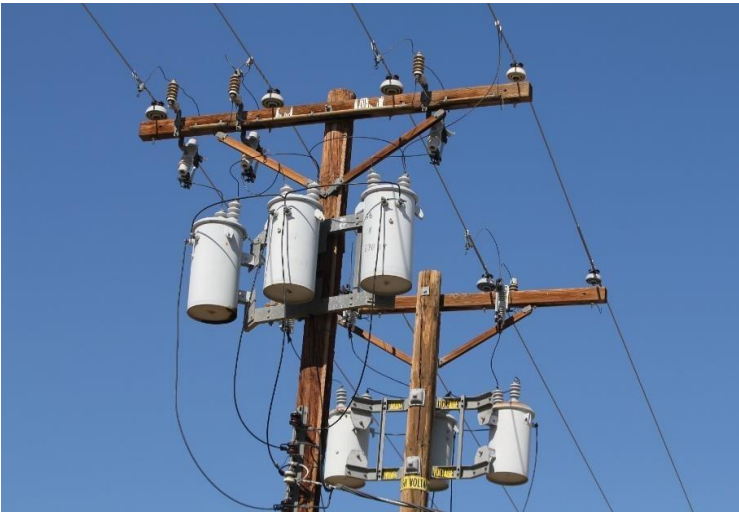
- 915803d Feeds ag. pump; Tracking, needs split bolt up top. Pole 10 ft away has no number, needs signs; steps for both poles

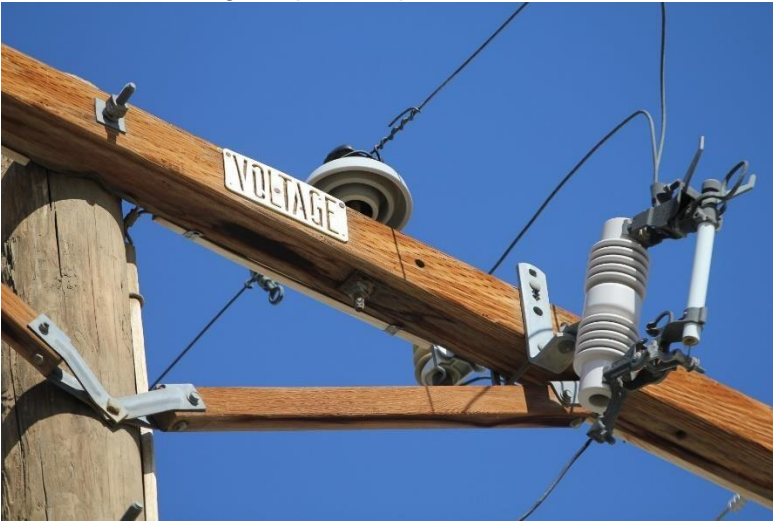
- 916124d tracking, no pole steps

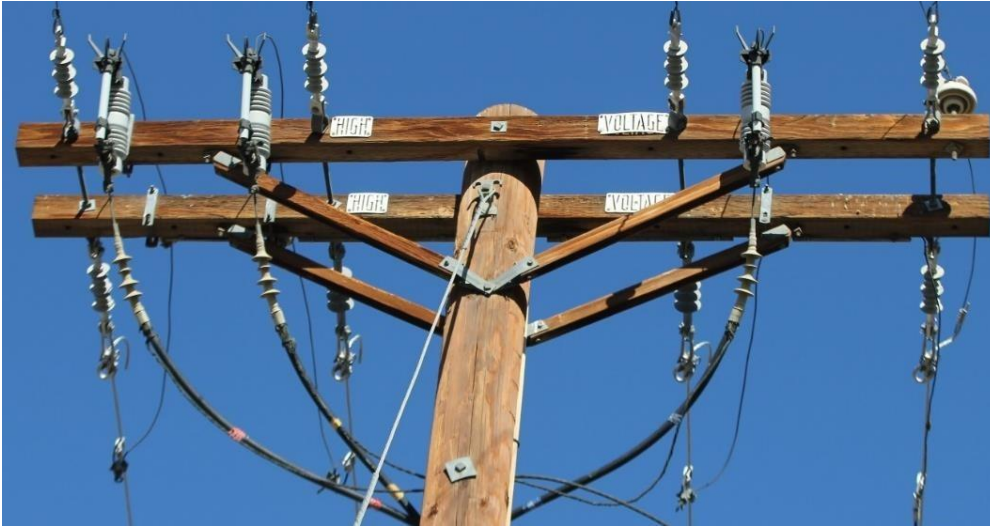
- 1093401d add load break cutouts, steps, relocate signs (High voltage signs should be placed on the outside of the arms),

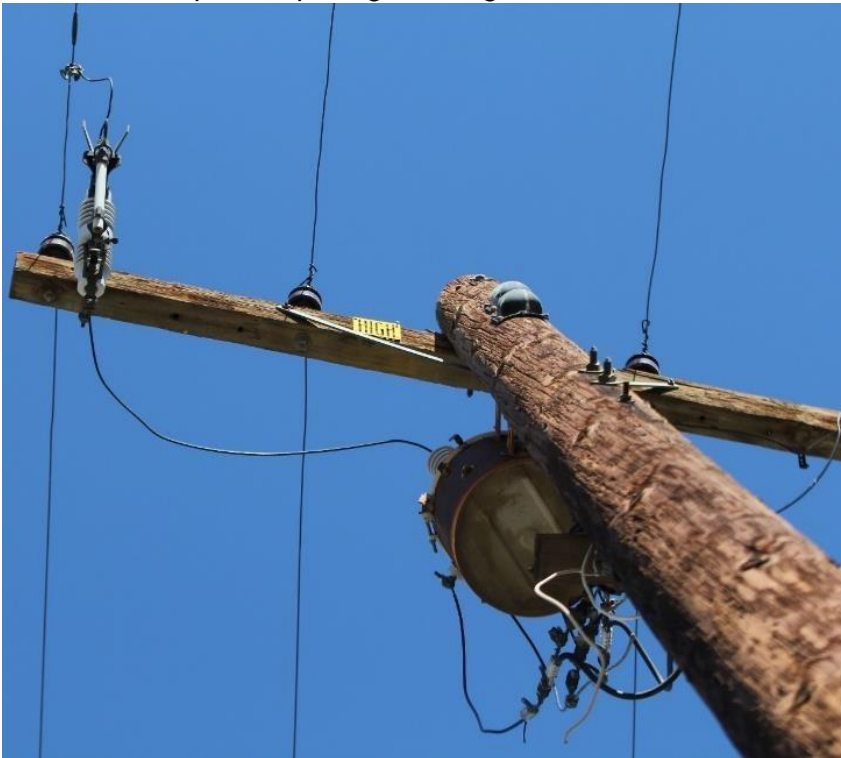
- 907173 need pole steps, high volt signs

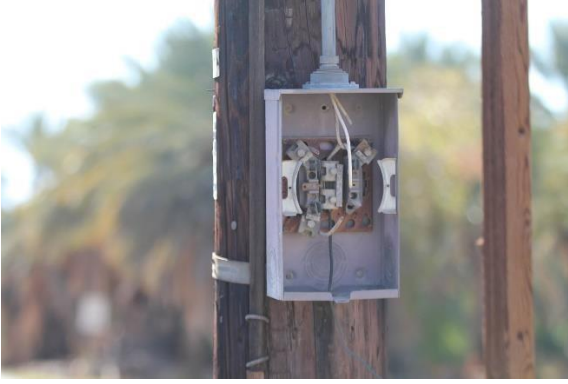
- (No number) – exposed meter base (pole not owned by IID)

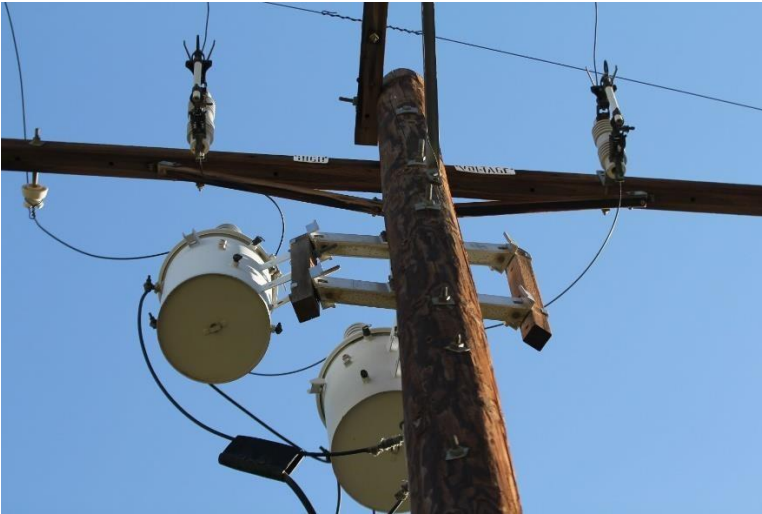
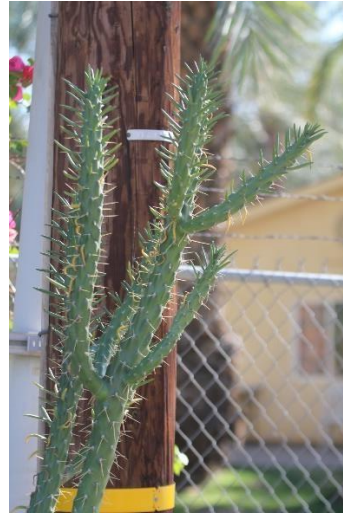
- 914257 tracking, no pole steps, remove cactus veg

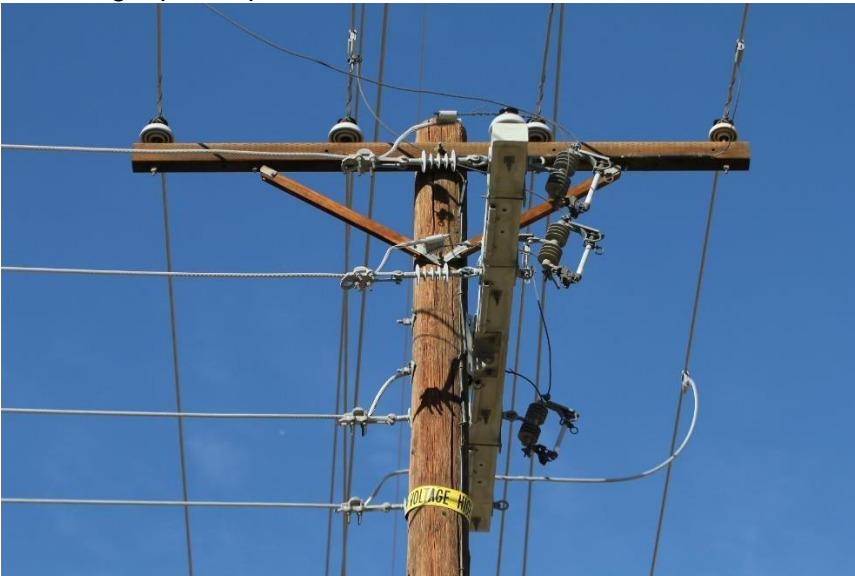
- 1219901 Doesn't make sense to install fused C/O's (Cutouts) in what appears to be a feeder circuit with a change of direction. We did not follow the entire circuit out. However, consider making the corner solid and installing a pole top recloser further down the line towards the load.

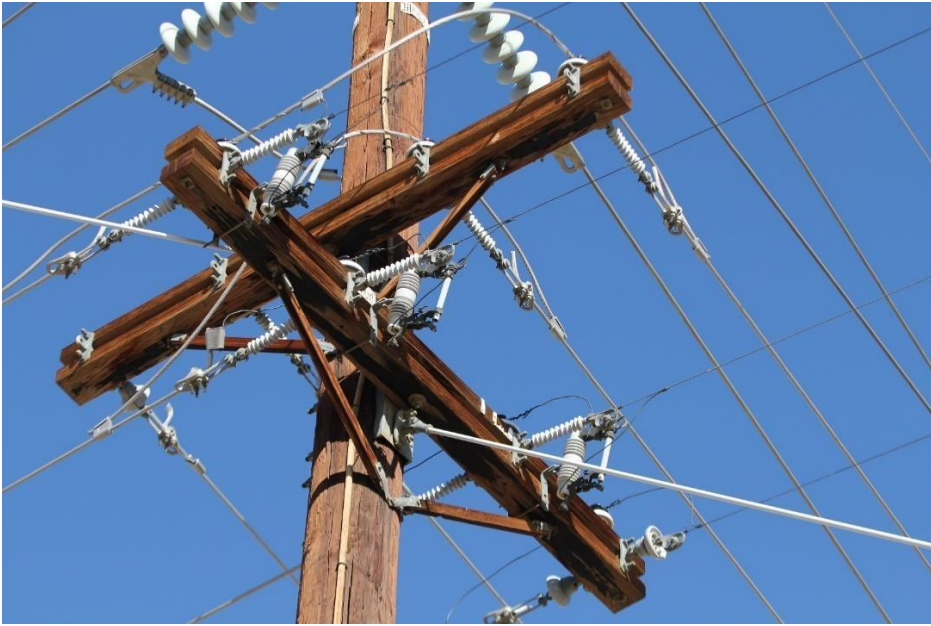
- T17914 tracking, need load break cutouts, tracking

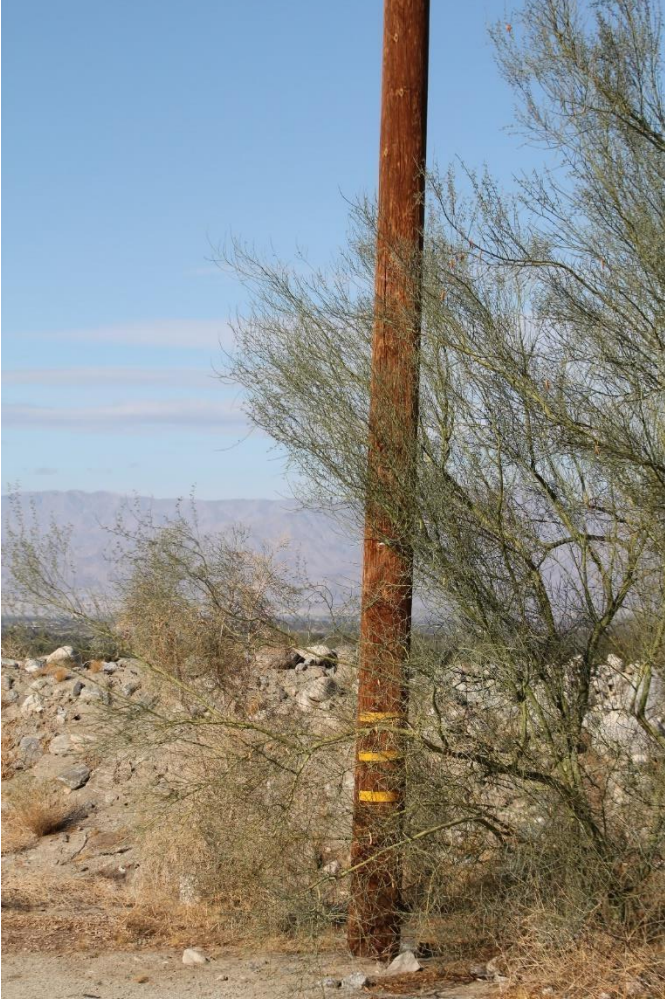
- 1094115 veg intrusion

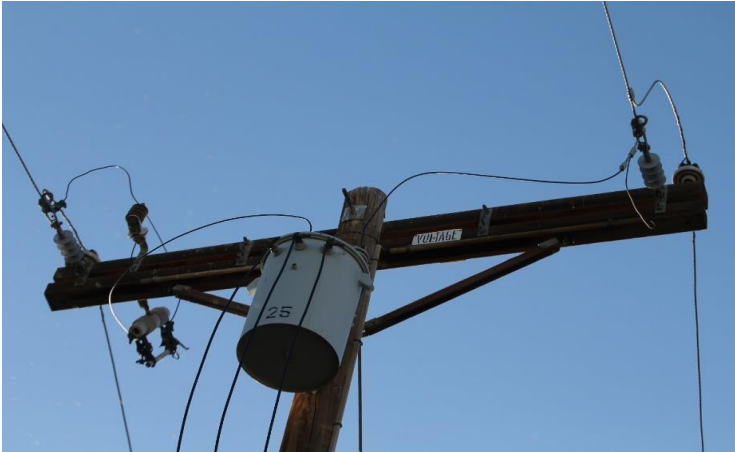
- 108311 Tracking when ground wire attached to line

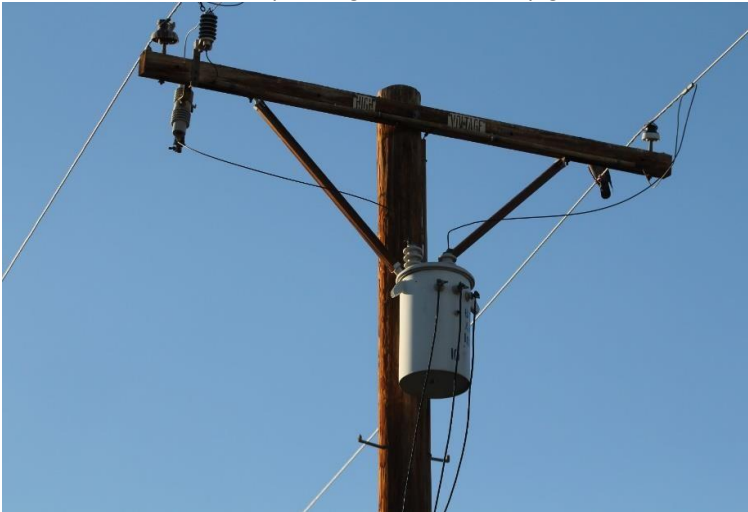
- Pole next to 96774 (can't get to number) ground on cross arm tracking

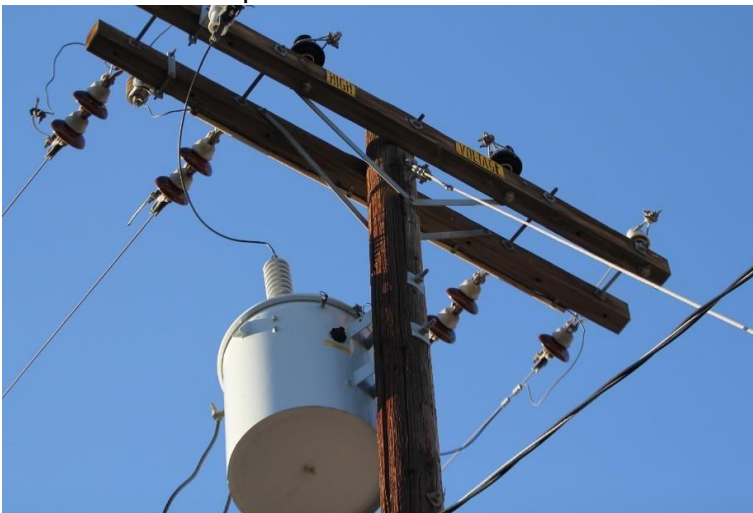
- 98718 no hard caps

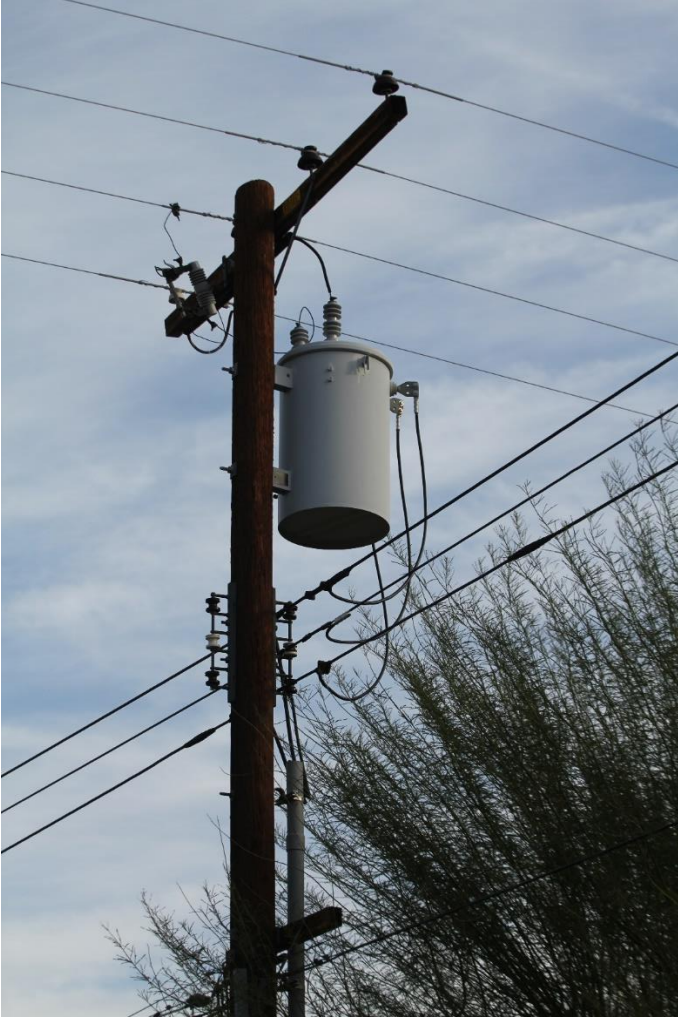
- 906952 veg intrusion, no lightning arrestor, no hard caps, no tracking on arm – the neutral wire is covered/insulated and is run through a PVC conduit

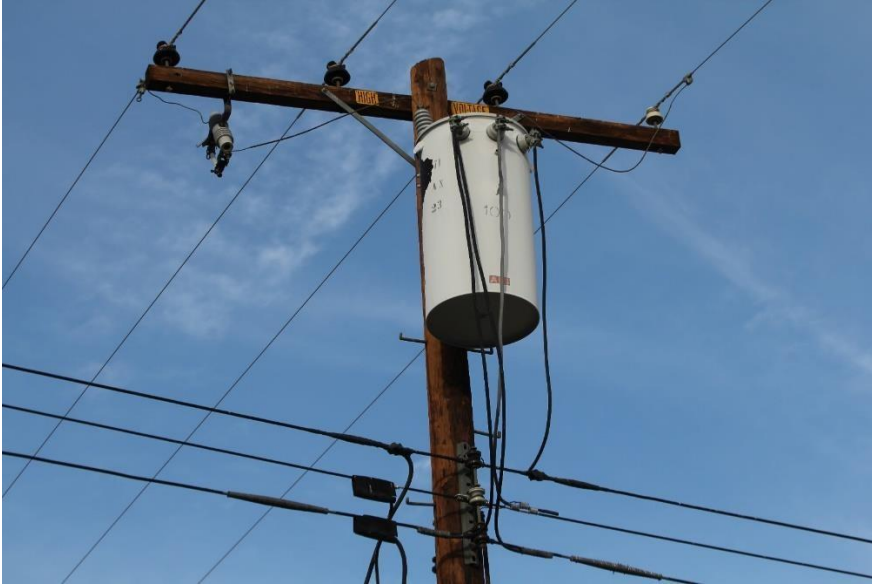
- 906953 Inconsistent construction standards – sometimes the neutral runs under the arm, other times it is a direct connection from the primary bushing to the CN. Additionally needs CN tag on the crossarm.

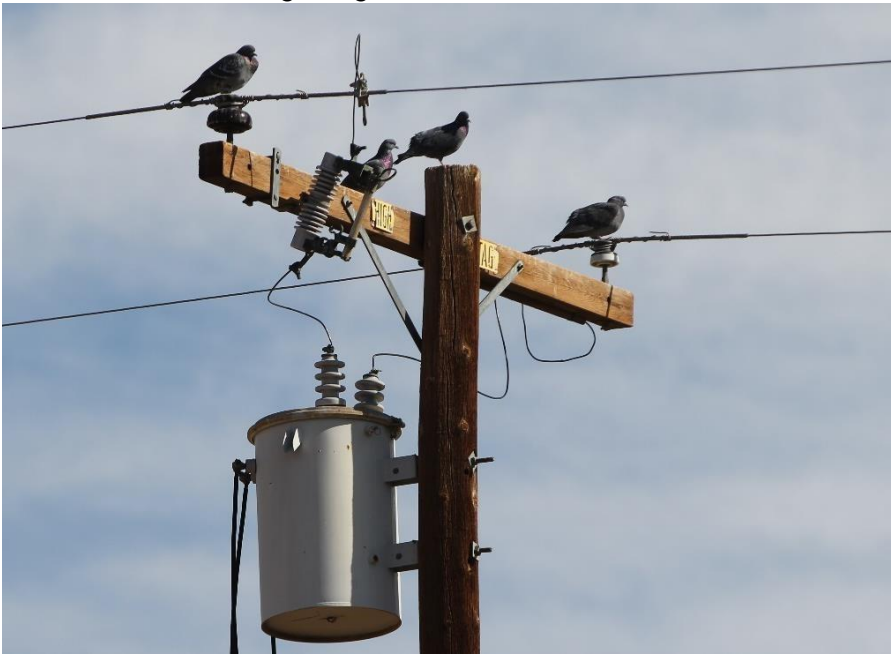
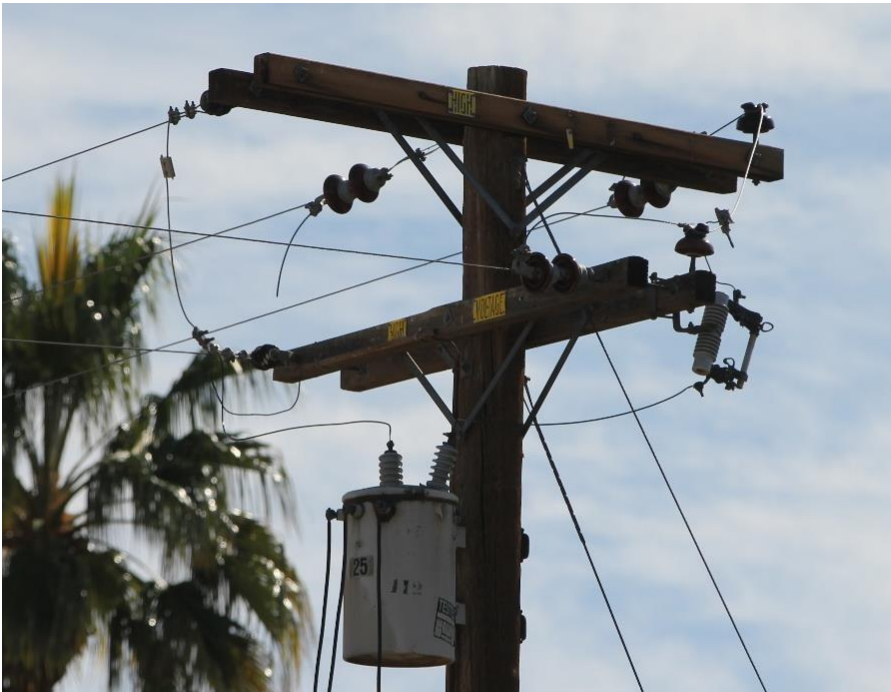
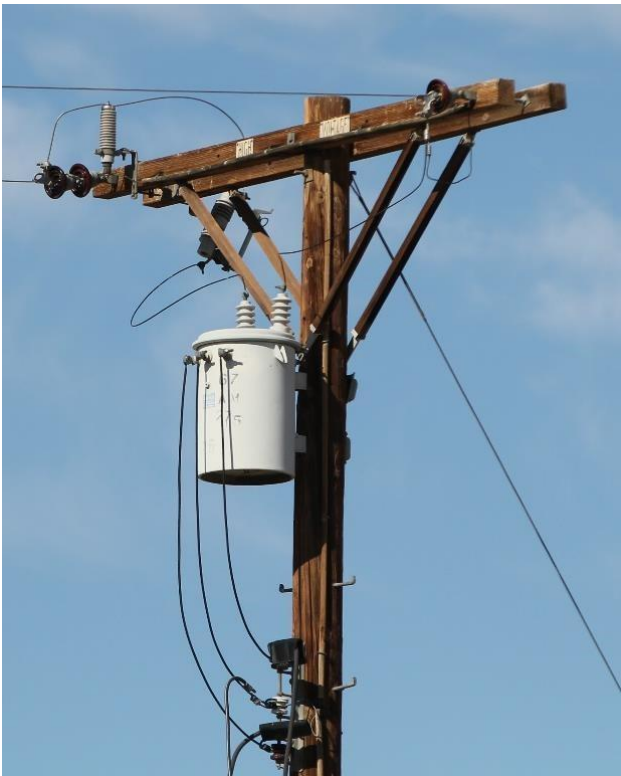
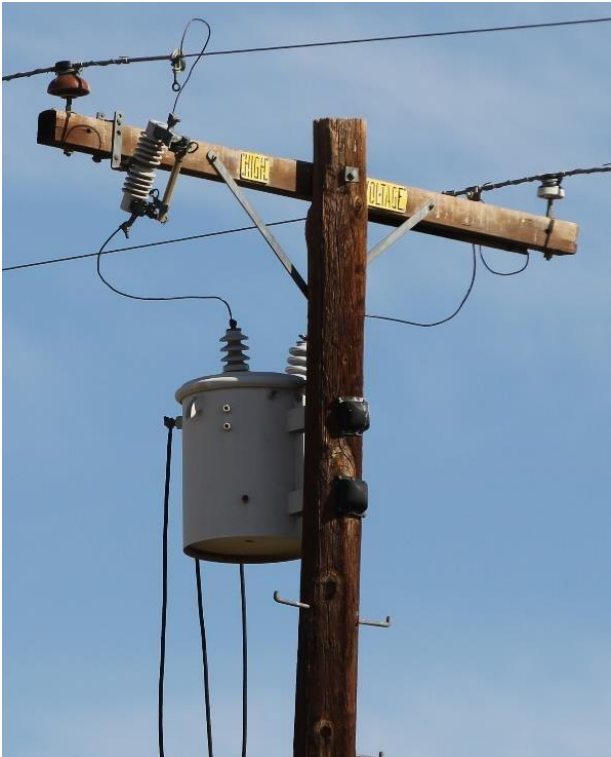
Final location: Bermuda dunes (backyard poles)

- Infrastructure looks good but more tracking than previous area, some bird issues; some inconsistencies with standards, e.g. surge arrestors
