Final Independent Evaluator Annual Report
on Compliance

Bureau Veritas North America, Inc.
Horizon West Transmission, LLC

June 29, 2021

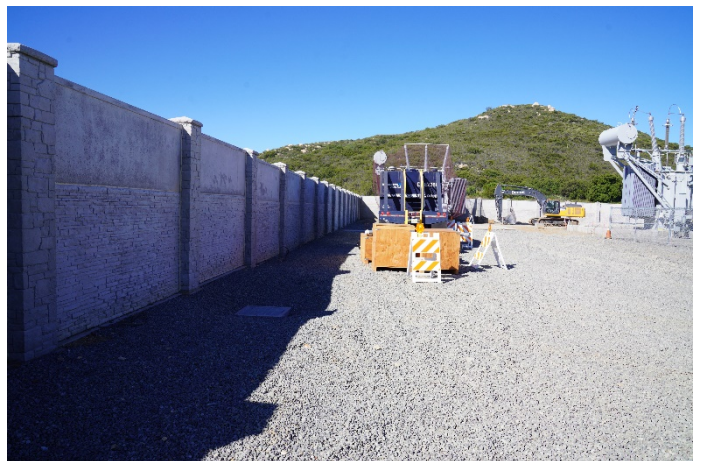
279 **Denbeste trailer, Spare Tx, View West, Wide view**

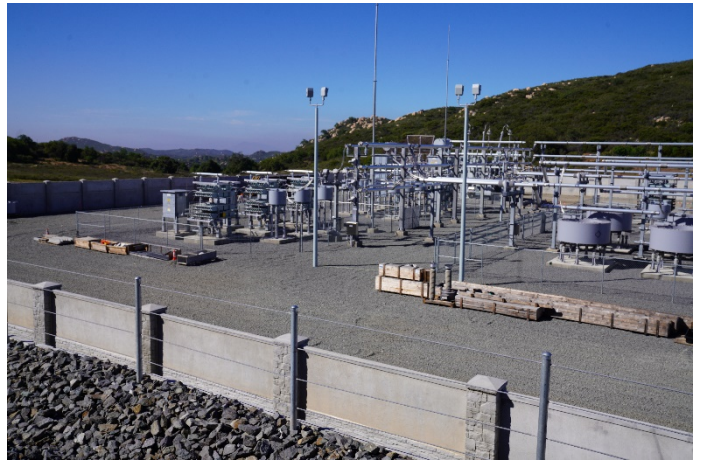
299 Capacitor banks, Reactors, Elevated view South

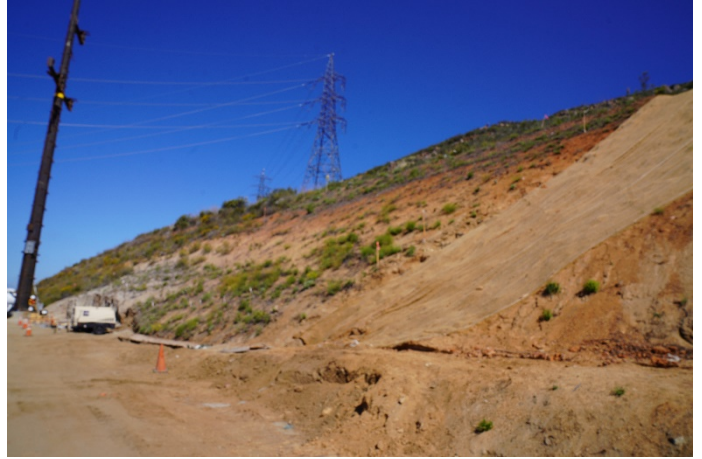
347

1 steel riser pole (empty), OHTL, material covering washout on hill, View Northwest
